## ***Geotechnical Due Diligence Study***

**GEOTECHNICAL DUE DILIGENCE STUDY  
48-ACRE PARCEL 8  
NORTHEAST OF INTERSTATE 5  
AND CANNON ROAD  
CARLSBAD, CALIFORNIA**

**Project No. 129452**

**November 15, 2012**

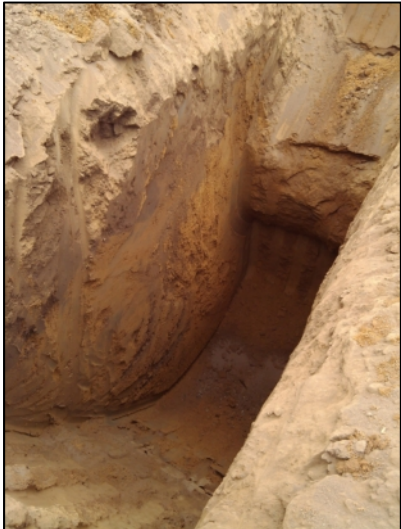
<b>Date Begin - End:</b> 9/11/12	<b>Excavation Co.:</b> Cut 'N Core	<b>TEST PIT LOG TP-2</b>
<b>Logged By:</b> E. Koprulu	<b>Excavation Crew:</b>	
<b>Hor.-Vert. Datum:</b> NAD83	<b>Excavation Equip.:</b> CAT 430E	
<b>Angle from Vert.:</b> 0 degrees	<b>Excav. Dimensions:</b> 24 in. O.D.	
<b>Weather:</b> Sunny

Approximate Elevation (feet)	Depth (feet)	Graphical Log	FIELD EXPLORATION	LABORATORY RESULTS								Other Tests/Remarks
			Latitude: 33.13818° N Longitude: -117.32842° W Approximate Surface Elevation (ft): 67.0  Surface Condition: Bare Earth	Sample Type	USCS Symbol	Water Content (%)	Dry Density (pcf)	Passing No. 4 Sieve (%)	Passing #200 Sieve (%)	Liquid Limit (NV=No Value)	Plasticity Index (NP=No Plasticity)	
			<b>Topsoil</b> <b>Clayey SAND (SC):</b> fine grained, dark brown, moist (upper 2 inches dry)									
			<b>Terrace Deposits</b> <b>Clayey SAND (SC):</b> fine to medium grained, reddish brown, moist									
			<b>Silty SAND (SM):</b> fine to coarse grained, reddish brown, moist, predominately coarse grained									
			<p>The exploration was terminated at approximately 8.5 ft. below ground surface. The exploration was backfilled with excavated material on September 11, 2012.</p> <p><b>GROUNDWATER LEVEL INFORMATION:</b> Groundwater was not encountered during excavation or after completion.</p> <p><b>GENERAL NOTES:</b> The exploration location and elevation are approximate and were estimated by Kleinfelder. There was no shoring used for the test pit exploration.</p>

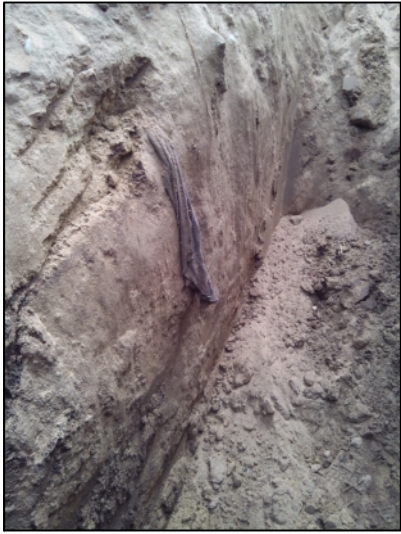
PROJECT NO.: 129452 DRAWN BY: CL CHECKED BY: KC DATE: 9/28/2012 REVISED: 9/28/2012	<b>TEST PIT LOG TP-3</b>  48-Acre Parcel 8 Interstate 5 and Cannon Road Carlsbad, California	PLATE  <b>A-13</b>  PAGE: 1 of 1
--	--	--

<b>Date Begin - End:</b> 9/11/12	<b>Excavation Co.:</b> Cut 'N Core	<b>TEST PIT LOG TP-3</b>
<b>Logged By:</b> E. Koprulu	<b>Excavation Crew:</b>	
<b>Hor.-Vert. Datum:</b> NAD83	<b>Excavation Equip.:</b> CAT 430E	
<b>Angle from Vert.:</b> 0 degrees	<b>Excav. Dimensions:</b> 24 in. O.D.	
<b>Weather:</b> Sunny
